DD Topic Complaint:
27T94041 **Slipping Or Flare On 2-3 Upshift at Partial Load**

Transmissions
722.3, 722.4, 722.5

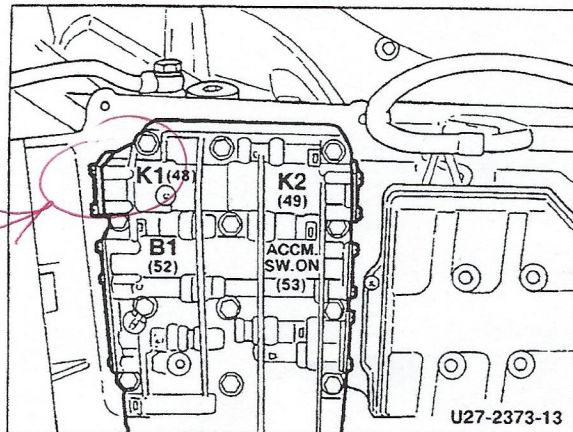
Figure 1

Reduction of friction coefficient in Clutch 1 inner discs.

1. Remove transmission oil pan.
 2. Unscrew end-plate of K1 accumulator (48) and remove accumulator piston with spring assembly (48, 48a, 48b).
 3. Install modified spring kit in K1 accumulator (48) of valve body accumulator housing.
- Note:**
Ensure seal rings on accumulator piston (48, Figure 2) are not damaged.
